Figure 1-3 Map of the Mixed Waste Landfill

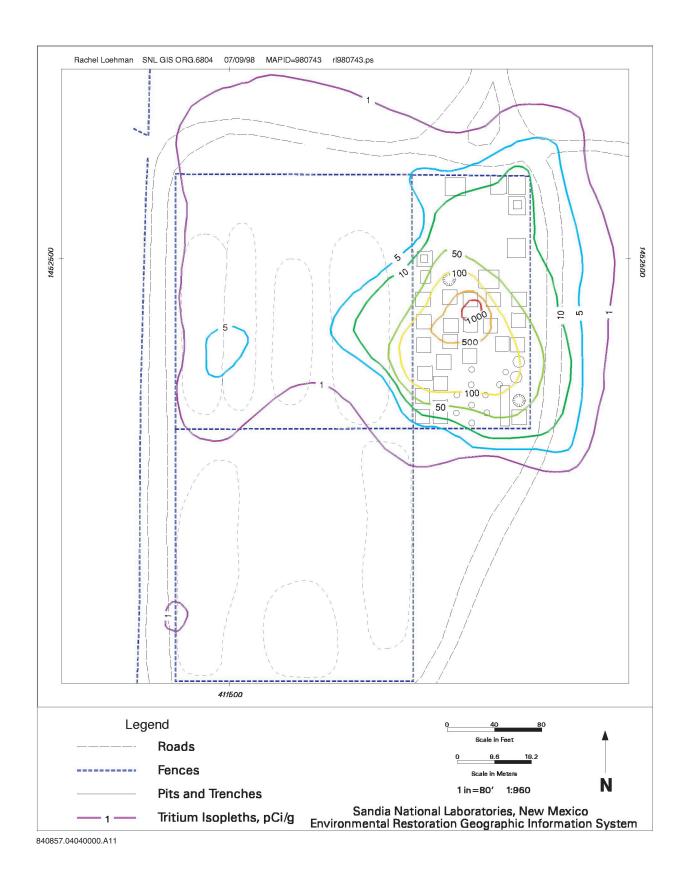
Figure 1-4 Tritium in Surface Soils at the Mixed Waste Landfill (1993 data)
